Response of RJ Lee Group
to the
United States Environmental Protection Agency Region IX
Response (dated April 20, 2006) to the November 2005
National Stone, Sand & Gravel Association Report
Prepared by the R.J. Lee Group, Inc [sic]
"Evaluation of EPA's Analytical Data from the
El Dorado Hills Asbestos Evaluation Project"

Regarding
Evaluation of EPA's Analytical Data
from the El Dorado Hills
Asbestos Evaluation Project

Exhibit A
Attachment A-3a
Lab/Cor Photographs of Particles

Date: July 2006

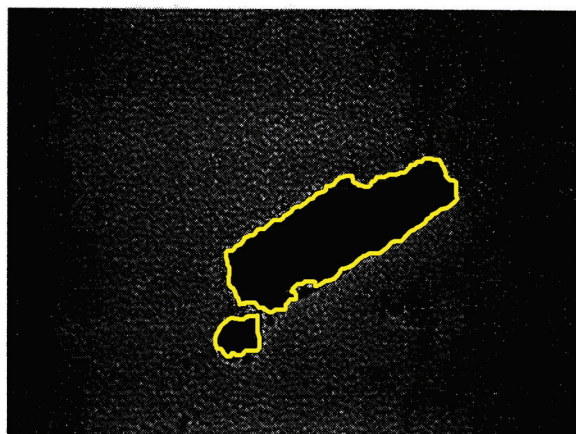
Neg#[254]; [Job# 041210-47]

Actinolite

Zone Axis [-2 -1 1]

13900 : 1

1μm

Element	Atoms%	Compound	Weight%	Error(±)	Norm%
Mg	8.44	MgO	15.53	0.95	15.53
Si	21.43	SiO2	58.76	1.64	58.76
Ca	4.91	CaO	12.57	0.64	12.57
Fe	3.60	Fe2O3	13.13	0.96	13.13
<Total>	100.00		100.00		100.00

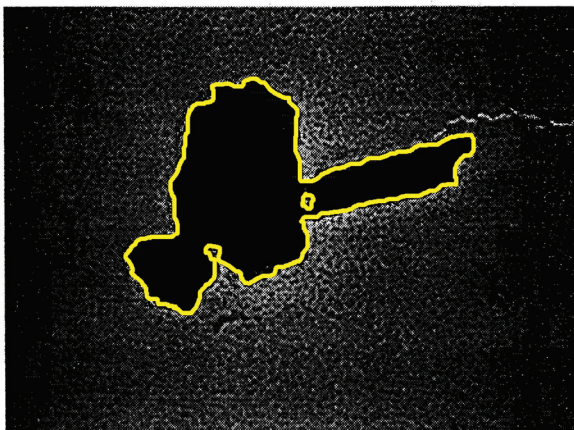
Zone Axis [5 1 4]

13900 : 1

1μm

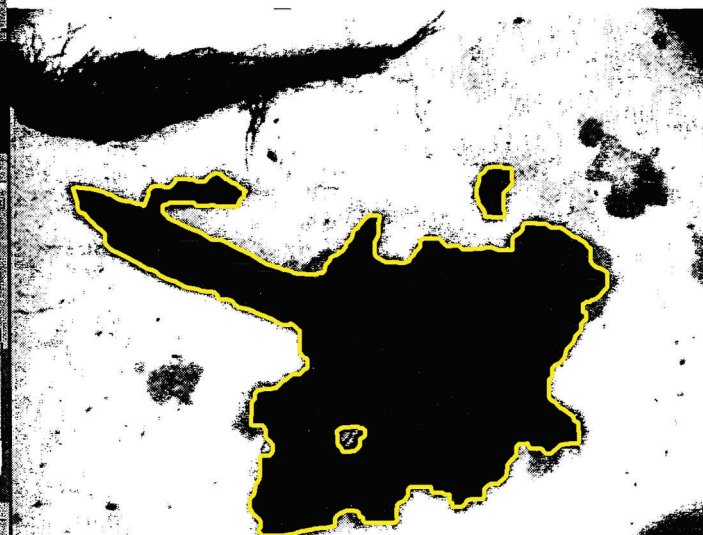
Title: 041188-101-SP1200 Time: 2:39:58 PM Date: Sat, Mar 26 2005 Accelerating Voltage: 100 KV Take Off Angle: 35 Degrees

Element	Atoms%	Compound	Weight%	Error(±)	Norm%
Mg	10.44	MgO	19.59	0.41	19.59
Al	0.08	Al ₂ O ₃	0.18	0.13	0.18
Si	21.17	SiO ₂	59.20	0.87	59.20
Ca	5.15	CaO	13.43	0.46	13.43
Fe	2.04	Fe ₂ O ₃	7.59	0.56	7.59
<Total>	100.00		100.00		100.00

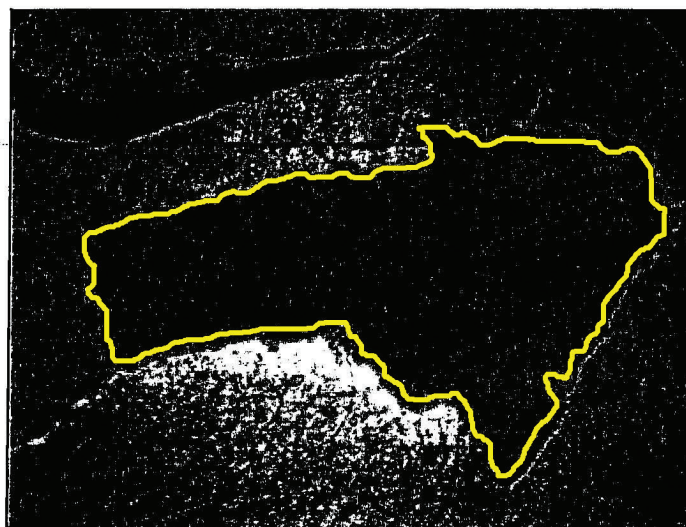
WINCHITE - Zone Axis [1 0 1]
Neg# J1601 Job# 050680-01
JEOL 1200EX - Gatan Image

Title: 050680-01 SP 1232 Time: 10:30:54 AM Date: Tue, Apr 19 2005 Accelerating Voltage: 100 KV Take Off Angle: 35 Degrees

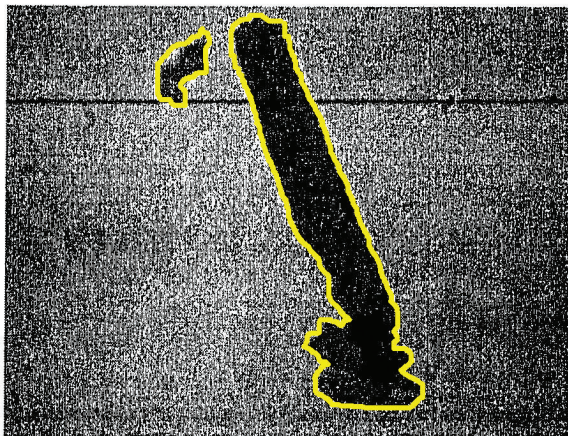
Zone Axis [2 0 1]

10200 : 1

2µm

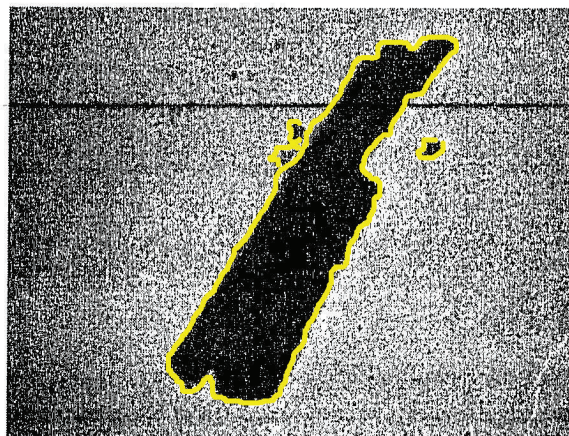
Zone Axis [5 -1 0]

11800 : 1

2µm

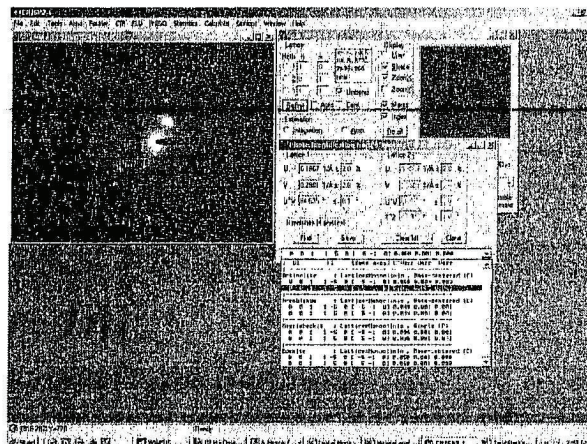
Quantitative Analysis Results - Standardless Analysis :
050680-07 EDS#16047 EDS Spectrum Mon, Apr 18 2005
EDS Parameters - 100KV, Takeoff Angle: 38.0°, Fit Index: 12.21

Element	Atoms%	Compound	Weight%	Error(±)	Norm%
Mg	9.35	MgO	17.27	0.98	17.27
Si	21.12	SiO2	58.16	1.71	58.16
Ca	4.78	CaO	12.28	0.65	12.28
Fe	3.36	Fe2O3	12.29	0.97	12.29
<Total>	100.00		100.00		100.00

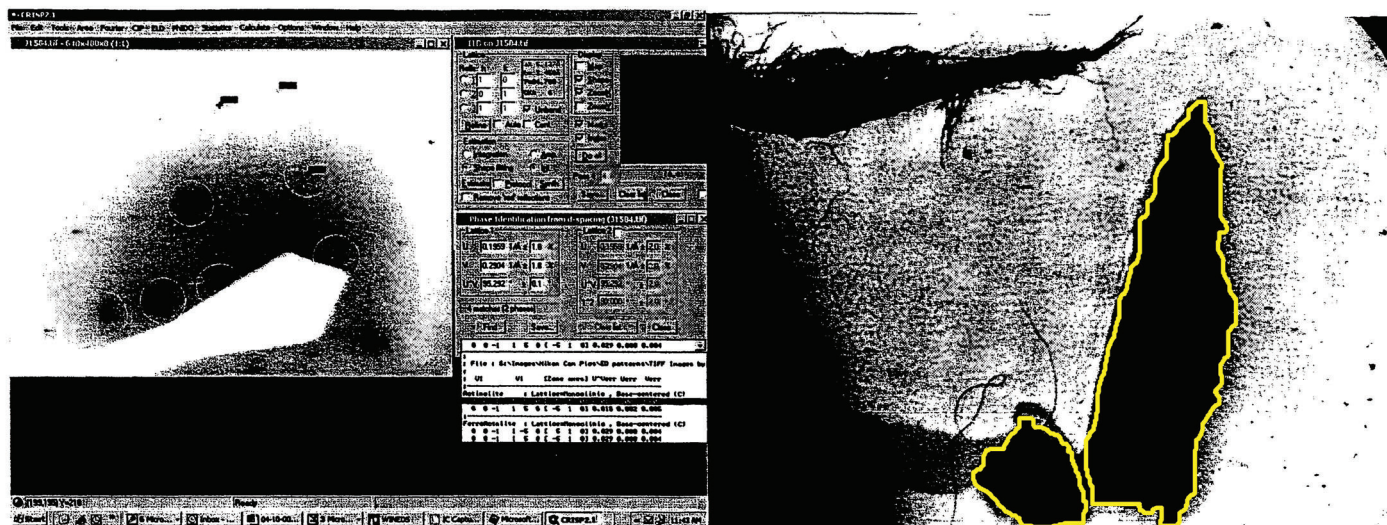
ACTINOLITE
[5 1 0] Zone Axis
041191-26, Neg#J1584

Title: 041191-26-SP1218 Time: 10:57:51 AM Date: Thu, Apr 07 2005 Accelerating Voltage: 100 KV Take Off Angle: 35 Degrees
